AML Management
Software 3.00

**Problem
Determination
Guide**

Document number: DOC E00 018-A
First published: 29 June 1999

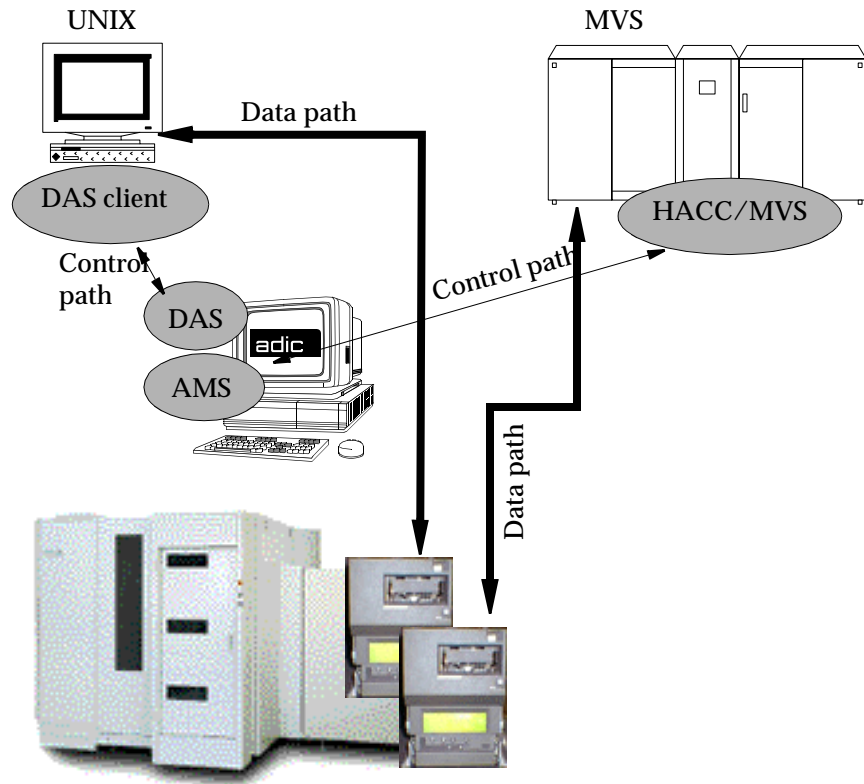
Figure 2-1: UNIX and MVS with shared AML

- (for each AML one AMU is required)
- is the central interface of the unmanned AML system
- conducts the configuration service for hardware related AML functions
- can be connected to several hosts
- manages a database (SQL database DB/2 for OS/2) for
 - assignment of volsers to compartments
 - cleaning media
 - groups for rewritable media (scratch pools)
- is the hardware on which the following programmes are running
 - AML Management Software (AMS) and
 - Distributed AML Server (DAS) (optional for connection of Distributed AML Clients)
- can be connected to a second AML to enhance the failure safety (dual AMU)

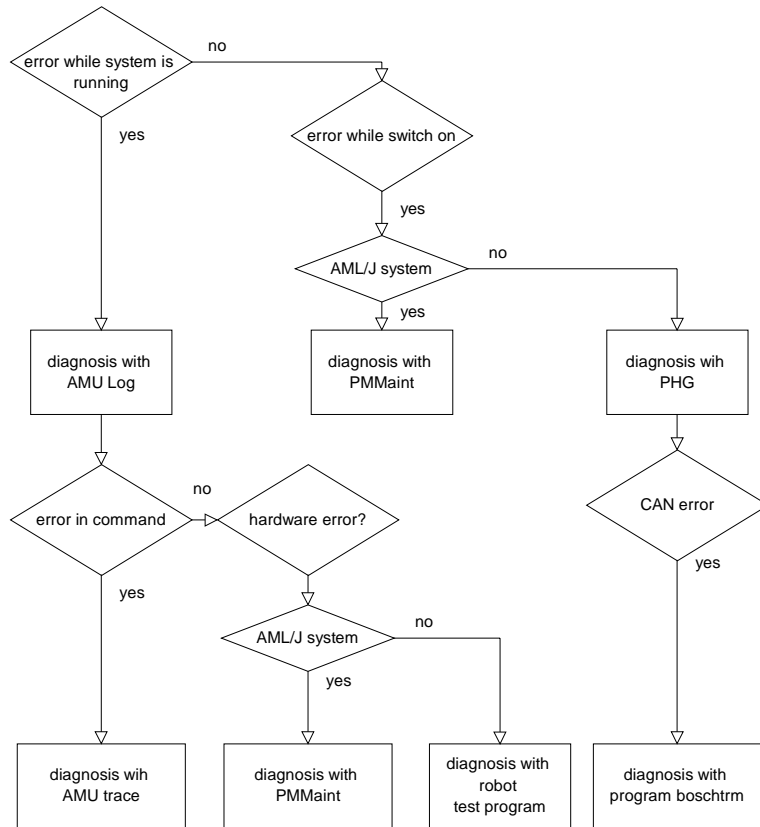
Figure 4-1: Diagnostic procedure and diagnostic tools

Tool	Explanation
AMU Log	Display all commands, error messages and status messages
AMU Trace	Display internal AMU procedure flows and the communication to other components
PMMaint	Independent program on the AMU PC to diagnose the PMAC board (AML/J control)
Robot test program/ operating system rho	Program on the AML/J and AML/E control for diagnostics with the manual programming device (PHG)
Boschtrm	Terminal program for diagnostic analysis of drive amplifiers (you need the start-up cable)
CM Trace	CM/2 software trace function to analyse a communication problem in LU2, LU6.2 or EXCP communication
DB/2 Query Manager	SQL database editor that can be used when a problem arises in the database
PE	PMAC Editor, diagnostic tool for the PMAC board (AML/J)
ACUSETUP	Terminal program to configure the AML/J Scanner
